# LEVEL II LAKE TAPPAN DAM NJ 00246

## PHASE 1 INSPECTION REPORT NATIONAL DAM SAFETY PROGRAM.

Lake Tappan Dam (NJ 00246). Hackensack  
River Basin, Hackensack River, Bergen  
County, New Jersey.  
Phase 1 Inspection Report.

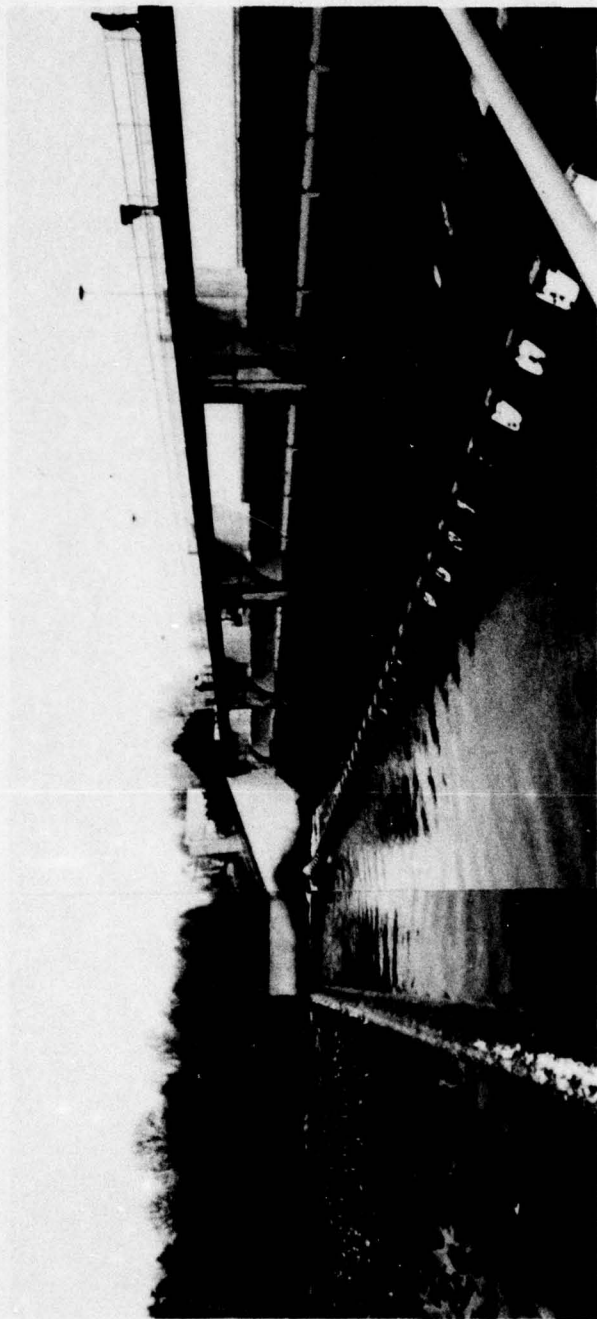
Photo 1 View of the Downstream Face of Spillway

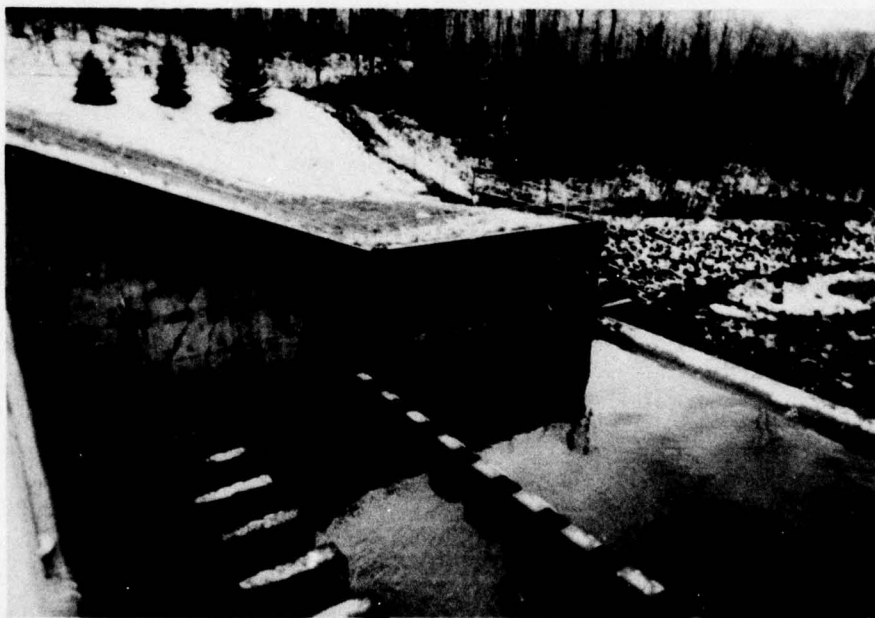
Several vertical and diagonal cracks with minor leaching were observed on the left retaining wall downstream of the spillway (Photo 3). Minor cracking was also noted at 6- to 10-foot intervals on the sill at the downstream edge of the concrete spillway apron. In addition, minor vertical cracks were observed in the right abutment retaining wall. These cracks do not appear to have any structural significance.

Photo 3    View of Downstream Section of  
Left Training Wall.

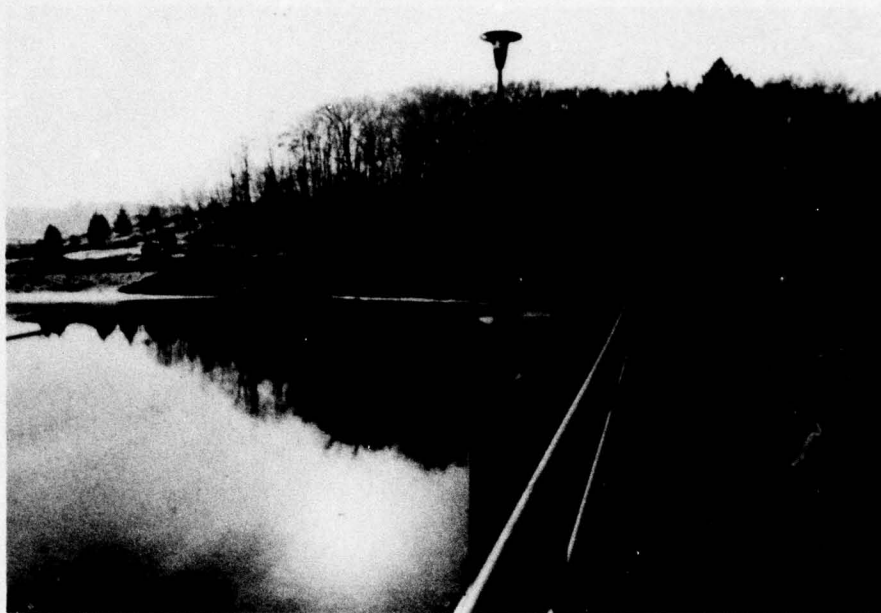
No vertical or horizontal offset or misalignment of the gate bay deck was observed (Photo 4).

Photo 4 View of Bridge Deck and South Bank of Approach Channel.

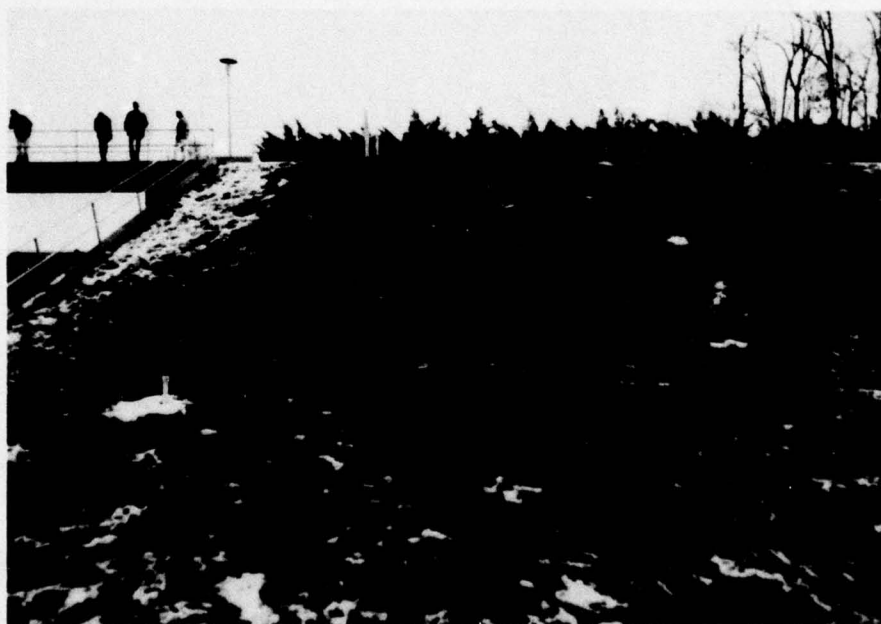
Two piezometers, one 15 feet above the toe of the embankment and one 17 feet below the crest, are located on each embankment section. (See arrow on Photo 5). The top of the upper piezometer on the left embankment (Plate 9, Piezometer No. P-1) has been broken off at the ground surface.

Photo 5 View of Left Embankment Looking Upstream Showing Top of Piezometer P-2 (Arrow).

(3) The piezometer located on the upper section of the left embankment should be repaired as soon as possible. The four piezometers should be read regularly to detect any irregularities in internal drainage and need for corrective action.

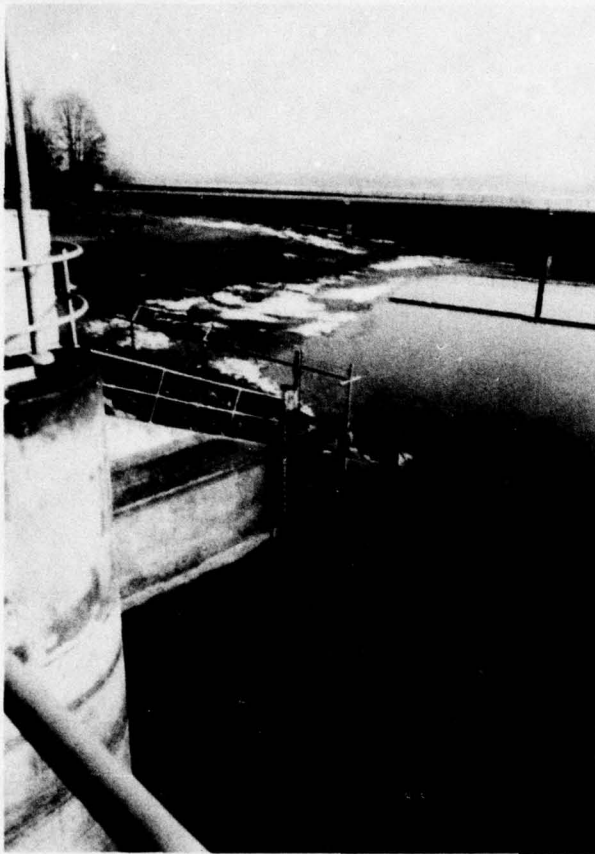
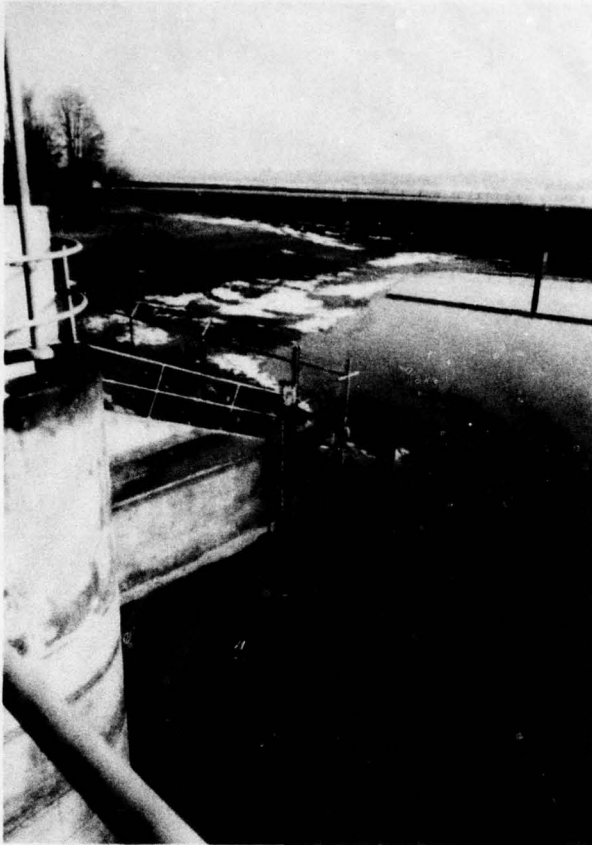
Photo 6 View of  
Upstream End of Right  
Training Wall Showing  
Staff Gages.

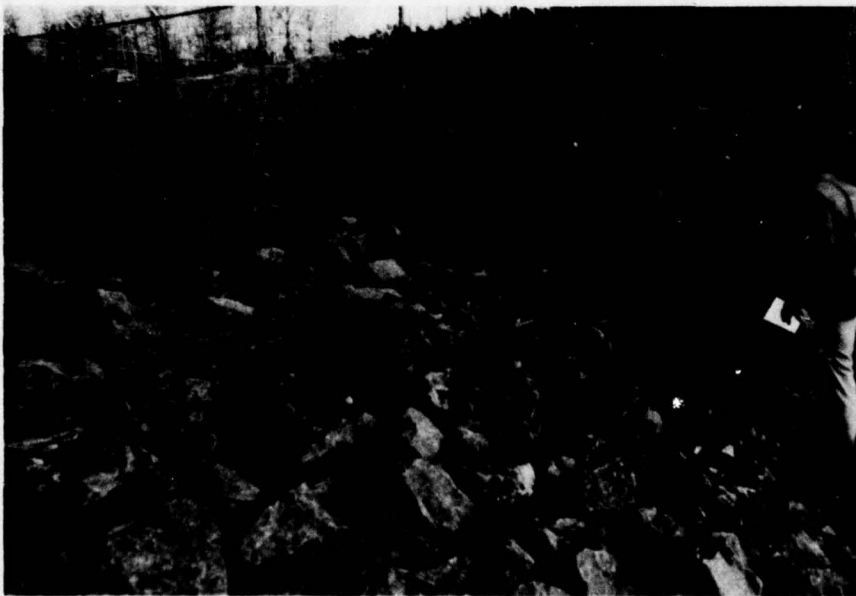
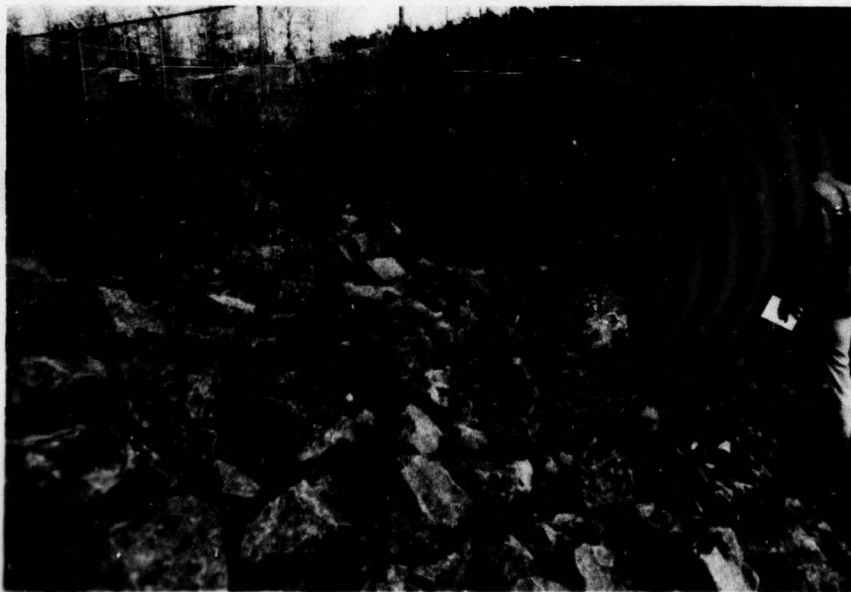
A minor seep flowing clear at a rate of less than 1 gallon per minute was observed approximately 10 feet downstream of the right embankment adjacent to the training wall (Photo 7). This seepage is possibly the result of recent rains exiting at the embankment toe drain outlet (Plate 9).

The minor seep observed downstream of the right embankment does not appear to be detrimental to the stability of the structure and is possibly associated with drainage through the embankment toe drain.

Photo 7 View of Seep (Arrow) Downstream of  
Right Embankment.

(1) The toe of the right embankment should be excavated in the vicinity of the toe drain exit to confirm if it is the source of the seepage noted in this area. If so, the soil presently covering the drain exit should be removed or replaced with free draining material. If not, steps should be taken to determine the source of seepage and to effect corrective measures.

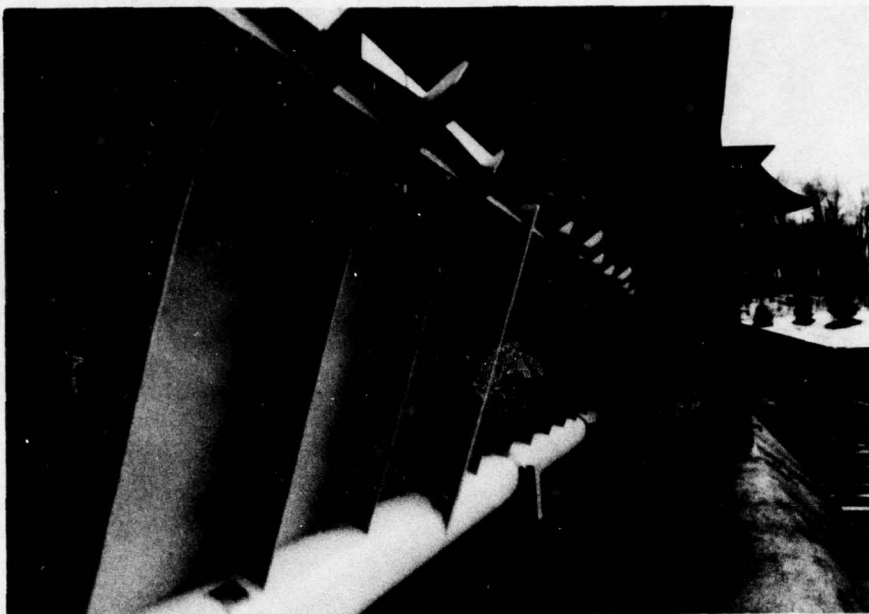
The visual inspection did not reveal any critical signs of distress in the dam. There was evidence of cracking and leakage in the gallery. In addition, cracking of the training walls and some spalling of the piers where they connect to the bridge deck were also observed.

Photo 8 View of Downstream Side of Bascule Gate No. 1  
Looking South. Arrow indicates Spalling at  
Top of Pier.
